## **Fatigue Analysis and condition assessment of FPSO Structures**

The paper describes the procedures applicable for the strength analysis and condition assessment of FPSO structures.

## 4 Repair of Fatigue cracks in side shell longitudinals of an FSO offshore Vietnam

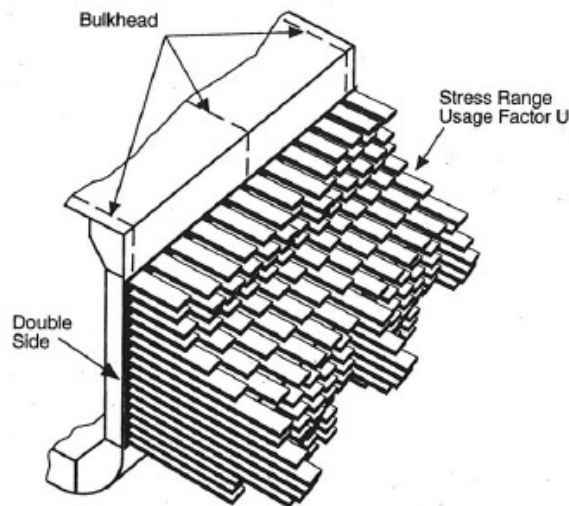
Fig. 5 shows the distribution of stress range usage factors  $U$  obtained for all intersections in the side area of two adjacent cargo tanks. Peak values can be observed at the bulkheads as well as below the sillwater line. Causative effects are relative deflections of webs and local pressure fluctuation, respectively. This is in agreement with the fatigue failures recorded by Yoneya (Yoneya, 1993). Based on the results, modifications can be defined in certain areas which reduce the local notch effects, for instance, by arranging brackets with soft toes at all critical points (see Sect. 4.2).

Fig. 5: Usage factors of intersections between side longitudinals and transverses

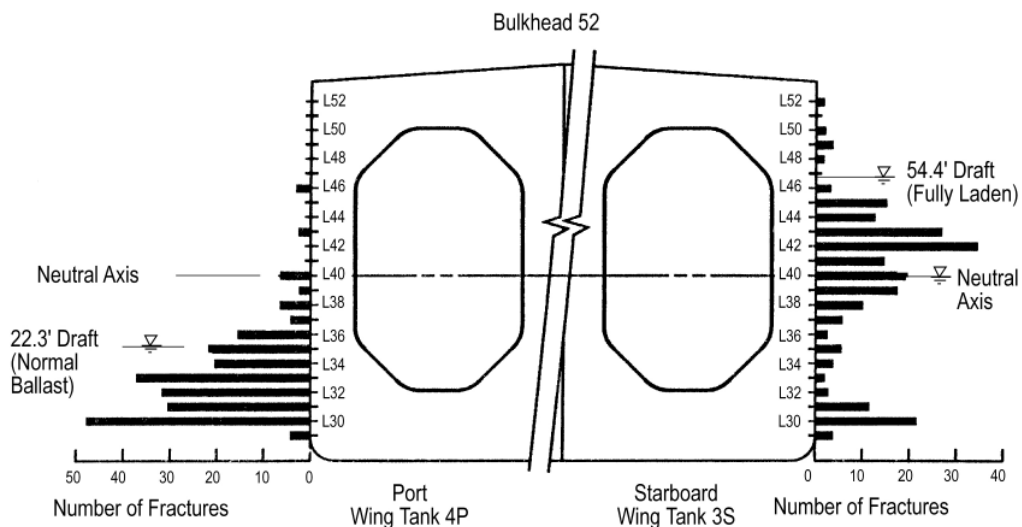
The effect of high fluctuating pressures close to or below the waterline has been investigated by Witmer (Witmer, 1994). Fig. 8 impressively shows the damages observed on tankers operating from Alaska to US west coast. Wave direction was mainly from one side, resulting in damages on the starboard side below the fully loaded line and on the opposite ship side below the ballast waterline. This damage scheme was verified by recalculation, using spectral analysis.

Fig. 8: Vertical distribution of side shell longitudinal fractures of the Atigum Pass Tankers

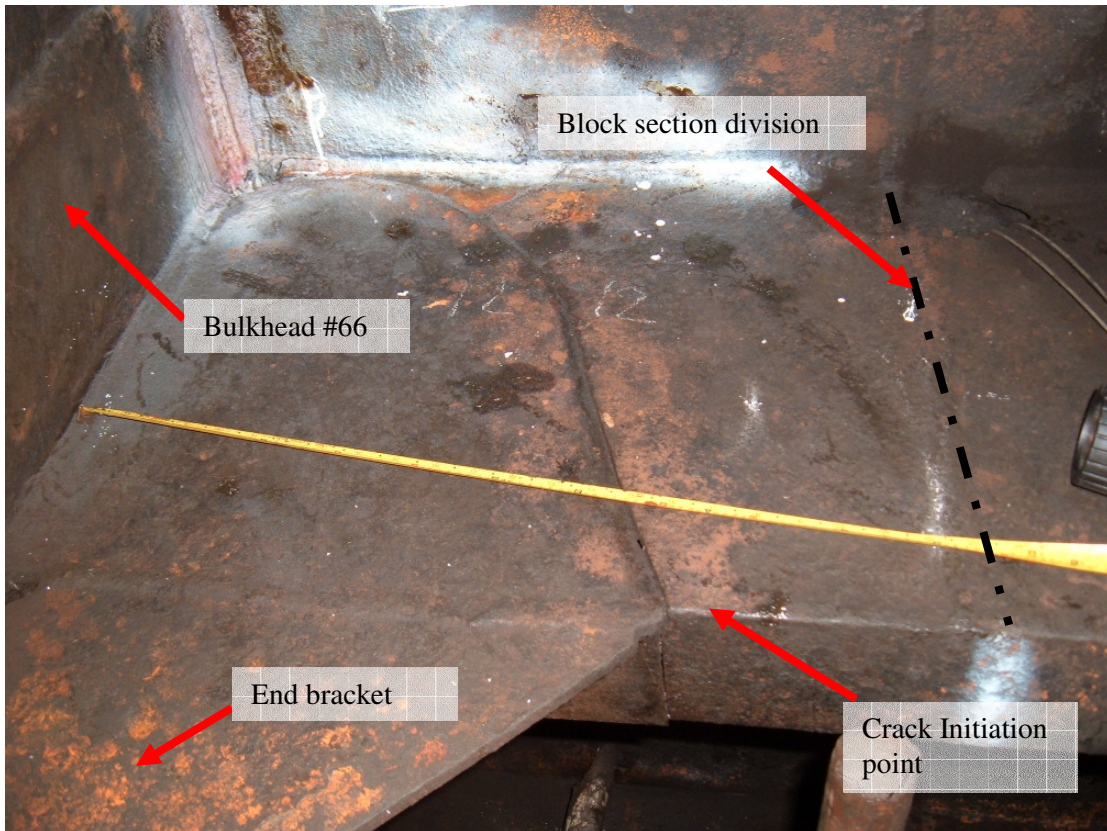
During the inspection from outside, in close vicinity of a tank bulkhead located approximately at mid ship a vertical crack about 300 mm long in the side shell was reported. The crack was crossing a longitudinal at about half height of the hull.

During the internal inspection it was observed that the L-shape longitudinal frame was fully ruptured. The crack has obviously started at a bracket attached to the frame at an end connection with a bulkhead. The photograph Fig. 10 and the drawing shown in The damage pattern is in excellent accordance to calculation results presented in Sect. 3.

Fig. 10: Longitudinal frame, fully ruptured

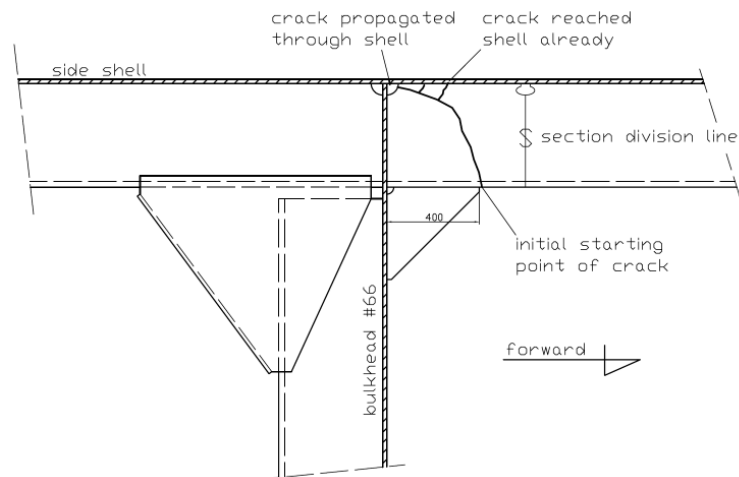
Further internal inspection showed that about 75% of the frames had cracks of different lengths, most of them visible to the naked eye. The cracks were all similar, starting at the end bracket where the frame is connected to the transverse tank bulkhead.

The longest cracks were found at about half height of the hull. This is a very clear indication that the dominating loads for the fatigue cracks are local wave loads rather than global hull girder bending loads.

Fig. 11: Original details of the longitudinal framing system in way of the tank bulkheads

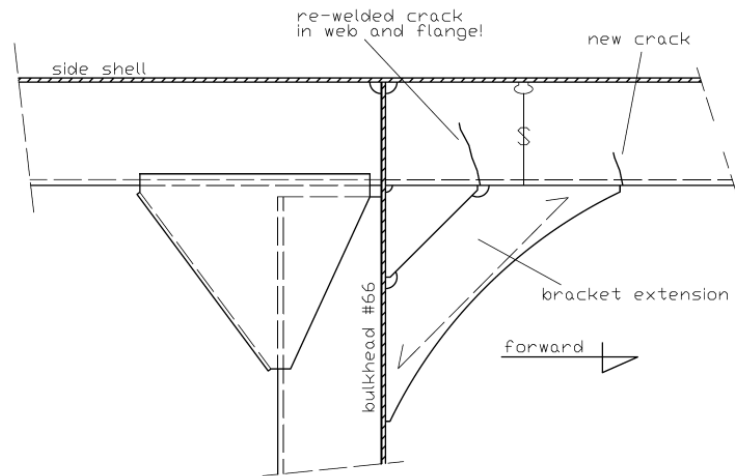
The inspection also showed that several repairs have been tried in the past with insufficient success. At some locations the cracks have been re-welded and an extension of the bracket has

been installed previously. Although the shape of the extension of the extension was somehow rounded, but this did not provide a sufficiently soft transition to the frame. Consequently the crack re-occurred at the end of the bracket extension. The damage pattern is in excellent accordance to calculation results presented in Sect. 3.

Fig. 12: Intermediate unsuccessful repair of unknown date

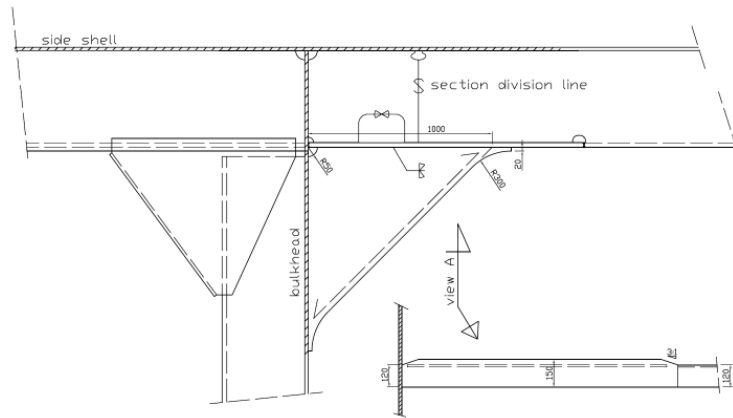
Fig. 13: Proposed repair, bracket with smooth end toes

Apart from the environmental conditions under which the repairs should be carried out a technical solution for an improved end connection of the longitudinals has been worked out. The objective was to achieve an increased fatigue life compared with the previous solution. Two significant modifications were proposed, see Fig. 13.

The shape of the newly inserted bracket, replacing the original small one and the previously added extension, shows soft toes at each leg end. Further it was intended to allow sufficient distance between the weld seams around the bracket and the edge of the L-profile. For the latter reason as well as to account for the effect shown in Fig. 7, the shape of the original profile was changed from a L-profile to an asymmetric T-profile, by cutting off the original flange and inserting a flatbar.
