## **Fatigue Analysis and condition assessment of FPSO Structures**

The paper describes the procedures applicable for the strength analysis and condition assessment of FPSO structures.

## 4 Repair of Fatigue cracks in side shell longitudinals of an FSO offshore Vietnam

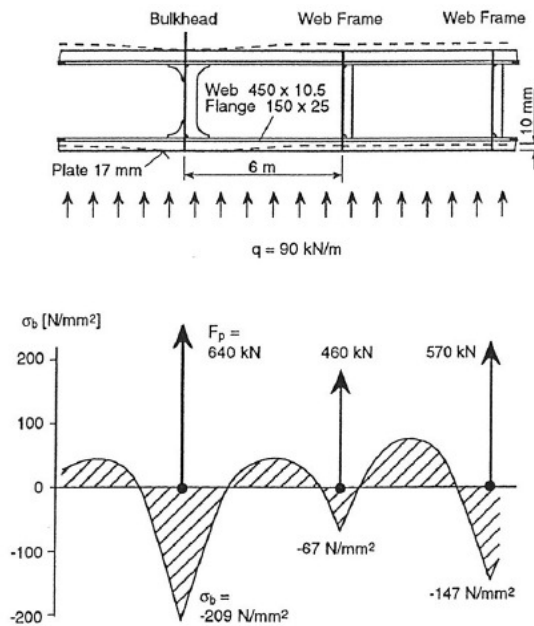
In the example of side longitudinals, not only global loads and local pressure are important, but also relative deflections of webs influence the stress response due to additional stiffener bending.

Fig. 4: Bending stress and supporting forces in side longitudinals of a FPSO

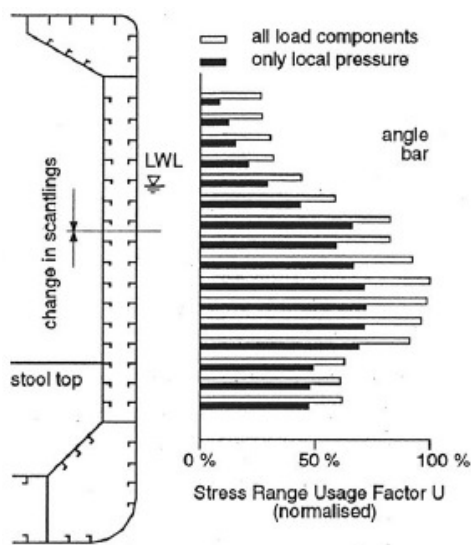
Results obtained for the intersections at one of the bulkheads are used in the following to illustrate the influence of some factors. Considering only the local bending stress due to the side pressure reveals the effect of global stresses and deflections on the total stress. Fig. 6 shows the resulting stress range usage factors  $U$  in comparison with the results including all load effects. It

becomes obvious that the fatigue life is considerably affected by the additional stress components, especially by the bending stress due to the relative deflection of primary members, which increase the stresses mostly in the critical area below the stillwater line.

Fig. 6: Effect of load components on the usage factor of side longitudinals

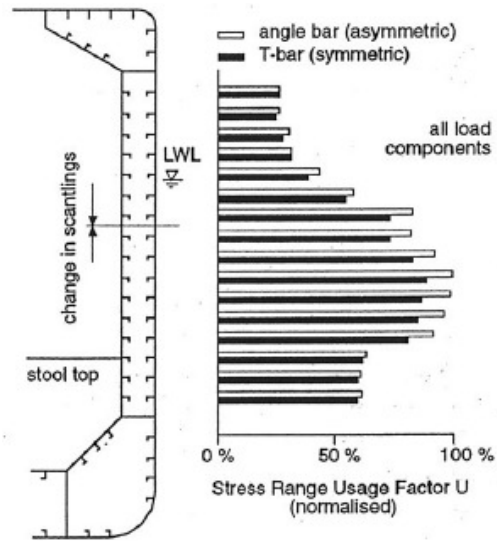
Fig. 7: Effect of the sectional shape on the usage factor of side longitudinals

Another important factor for local stresses is the sectional shape of the longitudinals. Fig. 7 shows the effect of the existing asymmetric section in comparison with symmetric T-bars. The difference is again mostly pronounced below the stillwater line, being in the order of 15%, which means a factor of about two with respect to the expected life time. An L-shaped section, where the flange is arranged at the side of the web and not at the top, would be even more critical because a buckling stiffener or bracket welded to the plate edge (i.e., the top of the web) belongs to the lower detail category “50” acc. to Germanischer Lloyd and International Institute of Welding (Hobbacher, 2007).

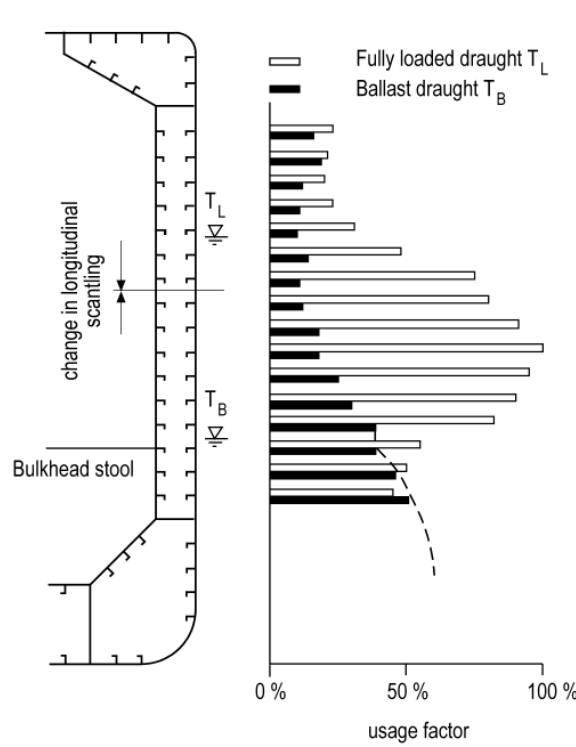
Fig. 9: Effect of draught on usage factors of longitudinals at intersections with web frames

Fig. 9 shows the effect of ballast draught and draught at full load condition on the fatigue life of the intersection of longitudinals with webframes. The bending stresses in the longitudinals caused by wave loads at each draft are the dominating effect on the fatigue life.
